## GLOBAL JOURNAL OF HUMAN-SOCIAL SCIENCE: B GEOGRAPHY, GEO-SCIENCES, ENVIRONMENTAL SCIENCE & DISASTER MANAGEMENT

# An Investigation of the Densification Process of the Residential Areas of Dhaka

By Syeda Jafrina Nancy & Roxana Hafiz

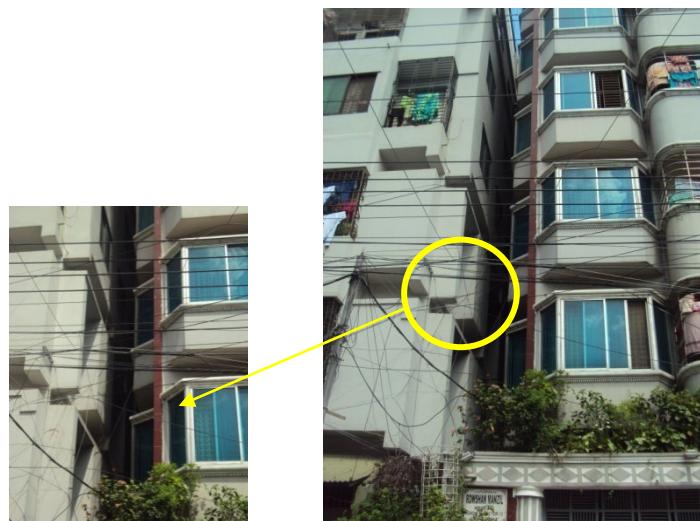
Figure 8: Dark alley between buildings

7 stories are not feasible for smaller lots the buildings are of 6-7 storied with plot coverage of 70%-80%. Six plots have a maximum coverage ranging from 83% to 85% which is a violation of the law. Only 14 buildings out of 41 complied with MINB 2008 properly while others slightly violated by raising the height of the front porch and guard room. In addition, the dark narrow setback space between the buildings cannot provide any meaningful use. Much of the development activity in this block started after 2011 for its peripheral location and for the late completion of the secondary road of Sonargaon Janapath. Overall, the linear plot configuration of the elongated blocks as well as the close juxtaposition of similar height buildings does not offer adequate provision for solar access, airflow and privacy contributing to a cramped situation.

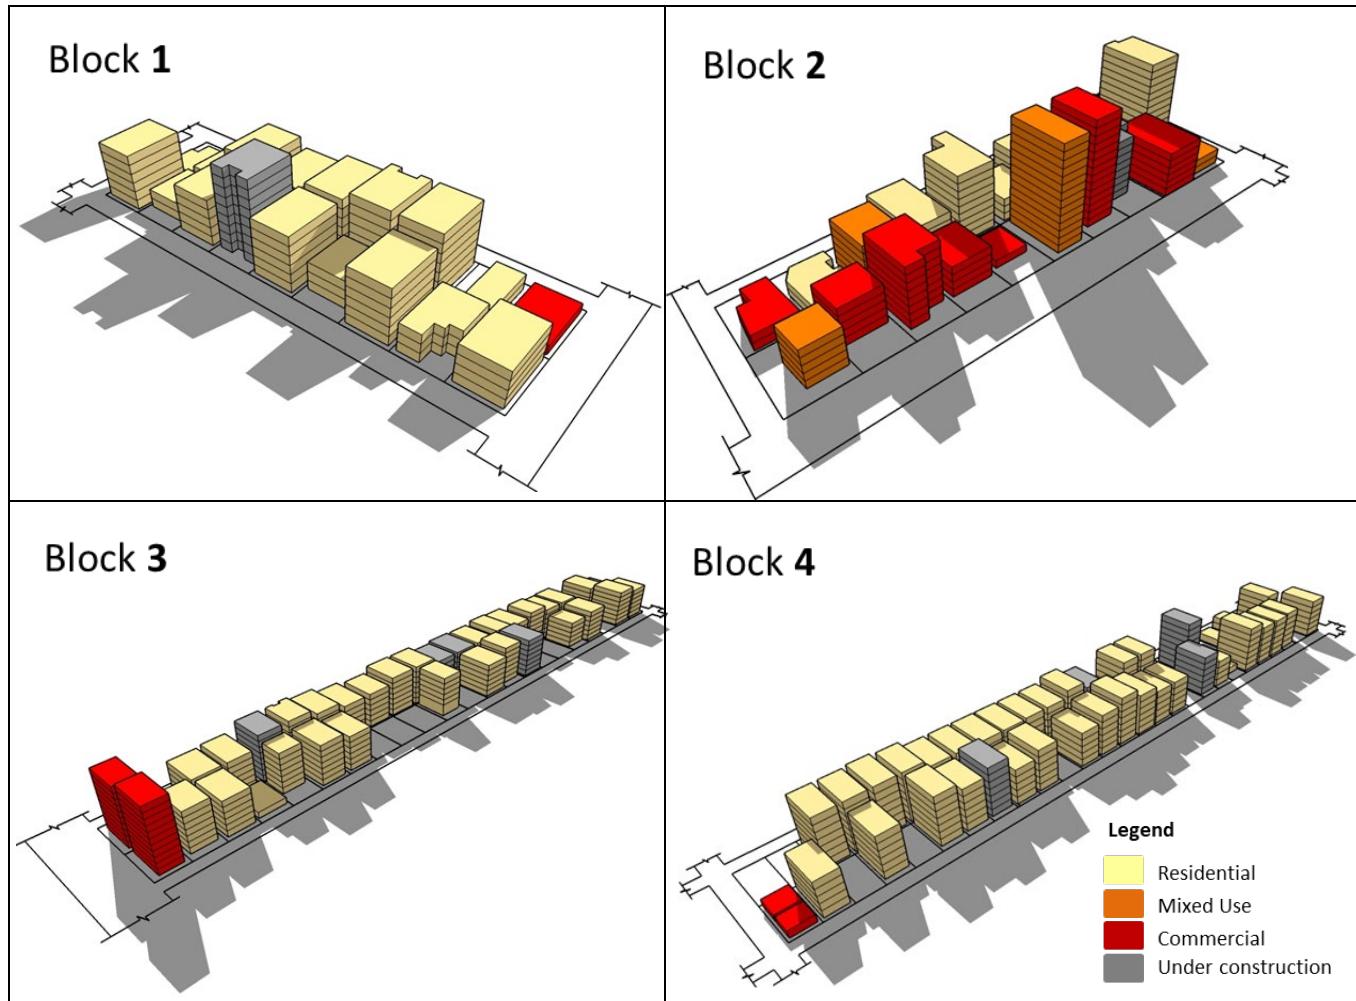
Figure 13: Shadowing of the blocks and adjacent roads, Uttara

The emerging spatial growth pattern of Uttara depicts that the residential area is heading towards a compact settlement pattern with varying height, size, and plot coverage. Around 10% of plots are still vacant and another 10%-15% with 1-2 storied dwellings. The similar height buildings juxtaposed to each other is resulting in poor spatial qualities of the indoor living environment in most of the blocks. The problem is further intensified in the longer blocks having more than 20 plots in a row. This type of block layout reduces the plot frontage likely to create cramped development. Since development is taking place plot by plot basis two types of skylines seems to be emerging where blocks along the primary roadside are forming an informally broken skyline pierced by 10-14 storied towers at irregular intervals and the inner blocks having a uniform skyline formed by rows of 6-7 storied residential buildings. Overall, such a spatial development pattern causes jagged skyline. In addition, the tower blocks are casting shadow on the adjacent buildings and streets creating dark corridors and hampering privacy of the

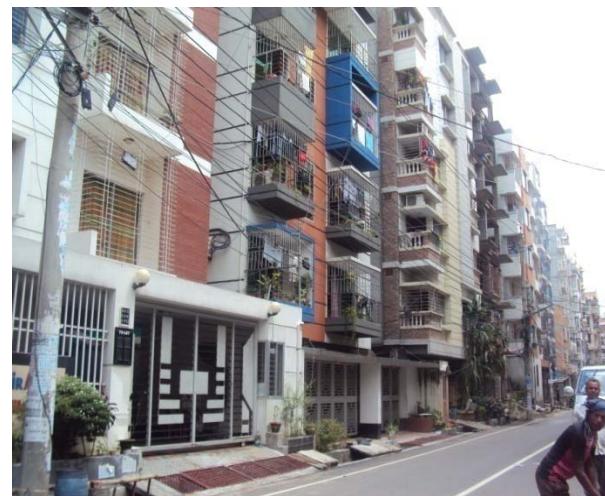
Figure 15: Mandatory open space is covered with roof of the extended porticos.

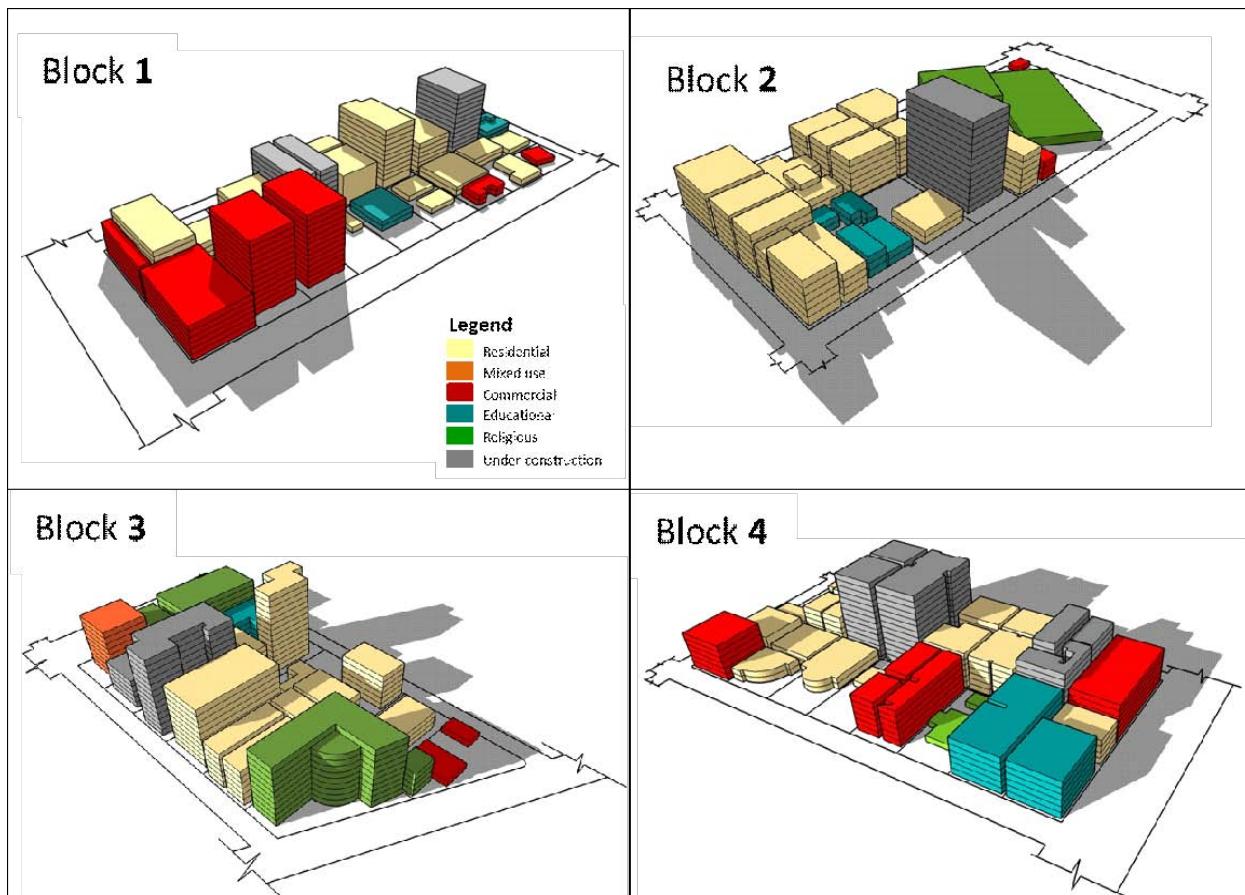
Figure 18: Shadowing of the buildings and the adjacent roads, Dhanmondi

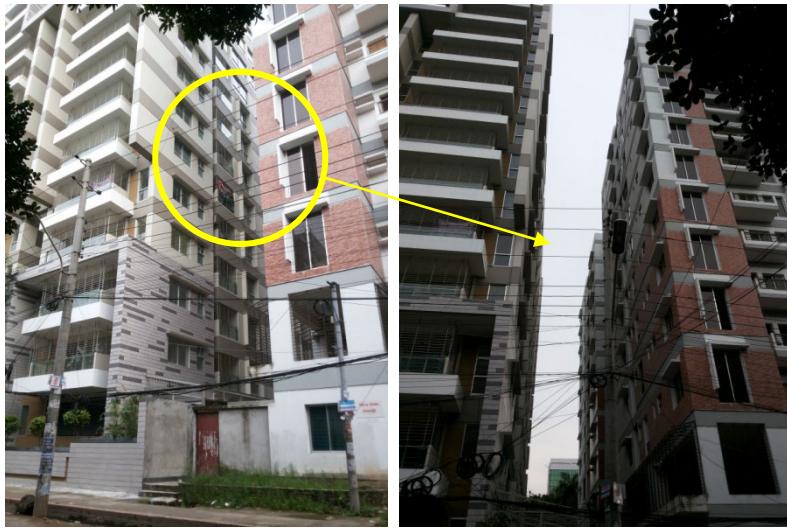
*Figure 19:* Requisite side setbacks maintained according to FAR between newly built high rise buildings blocks, Block-4, Dhanmondi

constructed 14 storied residential apartments in the middle. These towers have followed the recommended FAR leaving ample setback spaces around. But still these high-rise towers are overshadowing the nearby road and adjacent houses which results in lack of sunlight and privacy in the adjacent buildings.

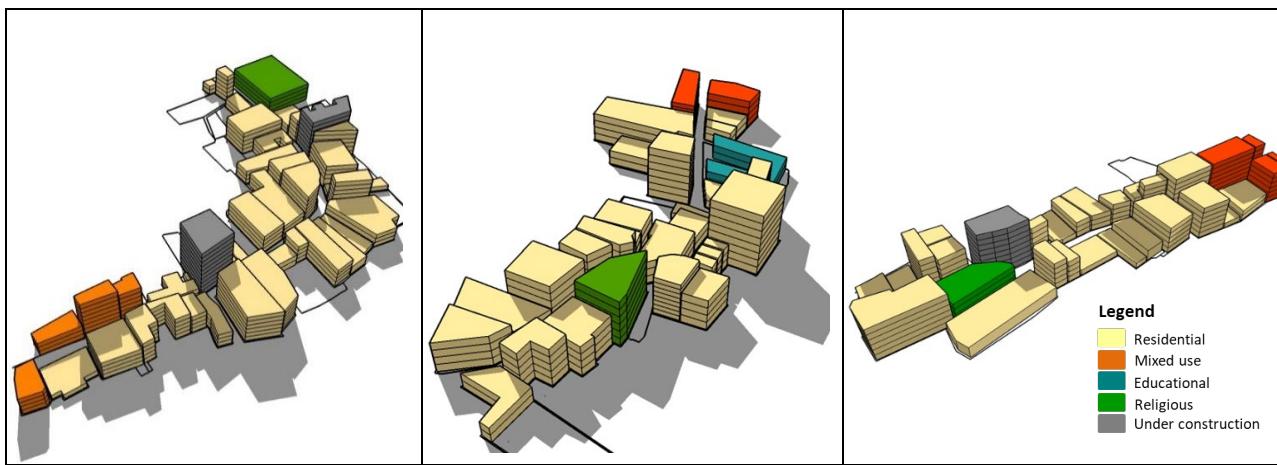
*Figure 28:* Shadowing of the buildings and adjacent alleys, Luxmi Bazaar

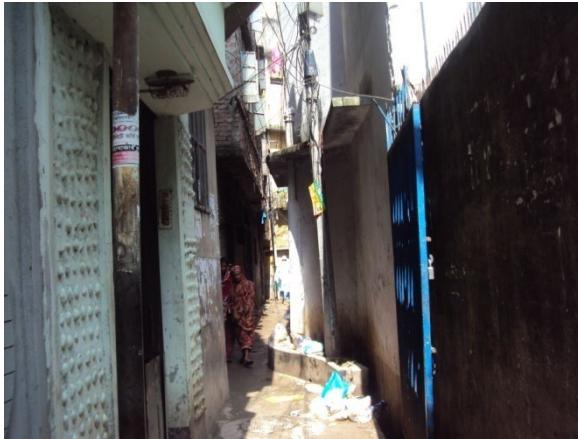
Figure 32: Narrow 4 feet wide alleys of Nobodip Bashak lane

Nobodip Bashak lane is characterized by a labyrinth of meandering narrow lanes 5-8 feet spreading out in various directions. Starting from the primary road (*Shubas Bose Road*) the lane is 16 feet wide at its entry point and 4.5 feet in its narrowest part. Both sides of the lane are flanked with 5-6 storied buildings with a maximum 1.5 feet setback space between buildings. In some cases, the distance of the balconies between facing buildings is less than 1.5 feet while two adjacent high-rise buildings are often found sharing the same external wall. The alleys are extremely narrow, often 4

feet wide with open drains on both sides. These alleys are only used as pedestrian pathways with 5-6 storied buildings overshadowing them. Various occupational groups reside here but a significant portion of them are service holders. There are a couple of mixed-use buildings in the entry point and a 4 storied mosque in the middle of the lane. The plot coverage ranges between 80 to 90 percent, in some cases even higher. With the highest plot and block coverage the high-rise dwelling of this dense neighborhood receives minimal solar access and natural ventilation.
