The Problems of Building Construction in Manacapuru-AM: The Correnteza and Terra Preta Neighborhoods

By Célia Regina Moretti Meirelles, Silvana Rodrigues de Oliveira, Rodrigo Carbajal Ballell, Thilo Gumbesch, Jair Antônio de Oliveira Junior, Maria Cristina Celuppi, João Paulo Assis Gobo, Flávio Marcondes, Silvio Sant'Anna, Lucas Fehr & Fabiane Ferreira Soares

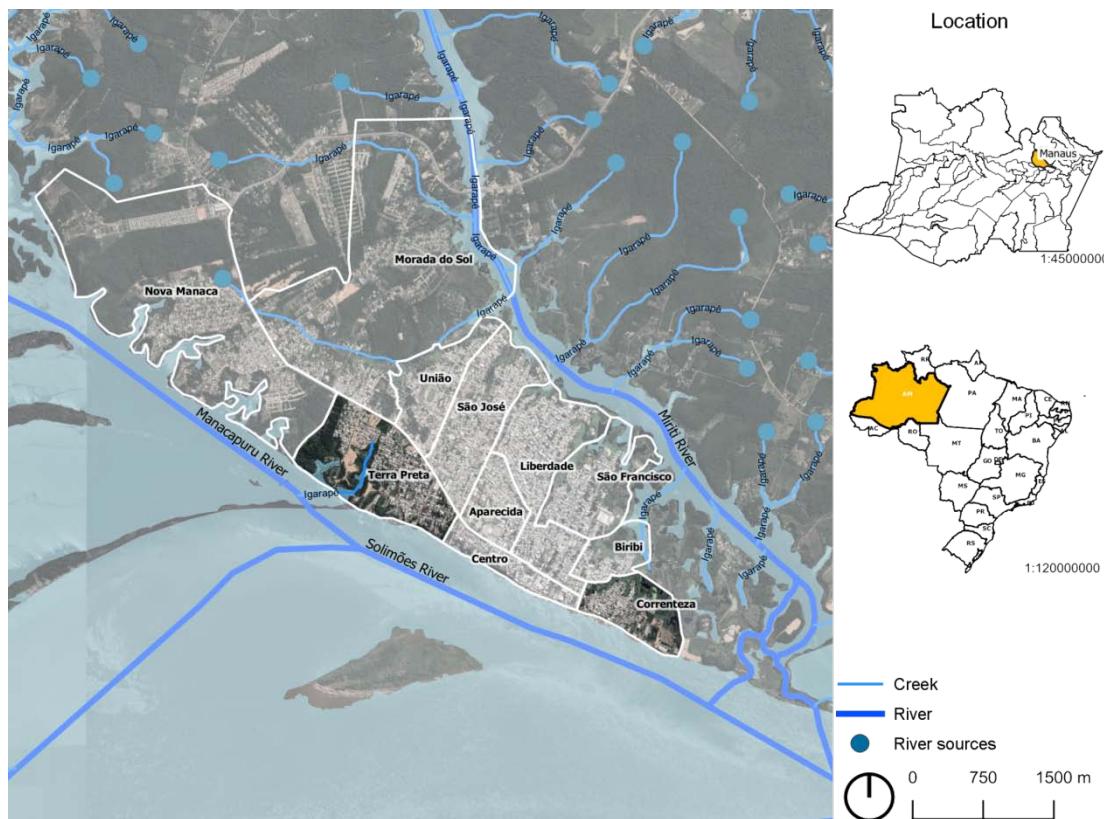
Figure 1: Maps of Manacapuru's situation and highlights of the two neighborhoods and the location in Brazil

In Figure 01, on the right, presents Brazil as the State of Amazonas, painted in yellow. The City of Manacapuru the case study are shown in Figure 01, on the left, with a focus on the areas around Correnteza, Terra Preta. And it is noticed that Bairro Correnteza is

located in a strip of land between two watercourses. The City grows towards the Northwest. Above the city is the network of streams that make up the water network of the Miriti River. Terra Preta is located in the central area of the town.

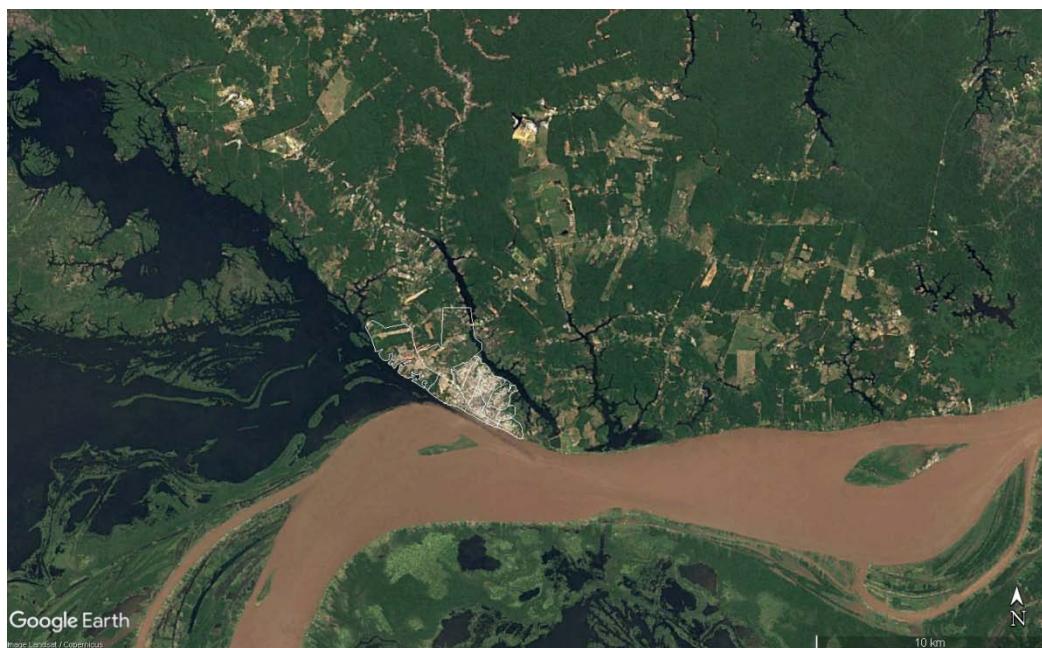
Figure 2: Map of the city and Amazon environment with hydrographic basin.

It is observed that "the municipality of Manacapuru-AM is delimited by two river basins, that of Solimões River and that of Manacapuru River" (Callegario & Ladeira, 2018). It is illustrated in Figure 02 that the city is delimited by several watercourses, such as the Solimões River and the Miriti, and that there is a wide variety of rivers and lakes, including Biribiri, Miriti, and Cabaliana lake. The meeting of the two takes place above the city, between the black waters of the Manacapuru River and the muddy waters of Solimões. On map 01, the blue of Solimões is imported from QGIS, however it is observed that the natural color of the Solimões River is muddy due to the "sediments that drain the eastern slope of the Andes mountain range". In black rivers, "it is due to the high concentration of iron sesquioxides" (Dantas & Maya, 2010, p.35).

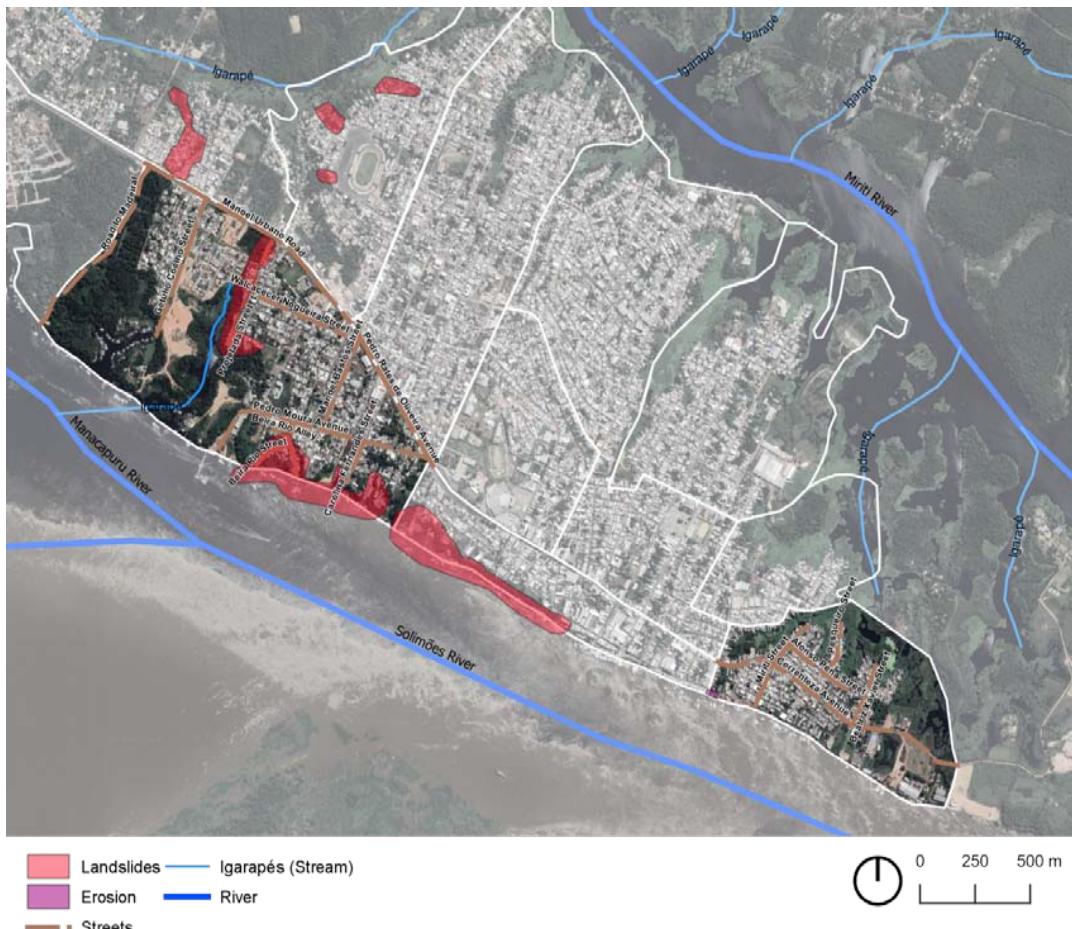
Figure 3: Maps of geological risk areas in Manacapuru

As already noted, the Manacapuru region, in addition to the risks of flooding, has areas with tendencies to have landslides and erosion. On map 03, the risk of regions the landslides was highlighted in red. The Brazilian Geological Institute classifies geological hazard risk as "very low, low, high, and very high" (SGB, 2018, p.1).

The map shows the critical geological areas on the edge of Manacapuru and next to streams. Thus, the risk class is high due to the conditions for landslide processes, as well as the "significant presence of signs/features/evidence of instability (cracks in the ground, slope steps, etc.)" so it is possible that "during heavy and prolonged rains the phenomenon occurs." (Lana et al., 2021, p.23).

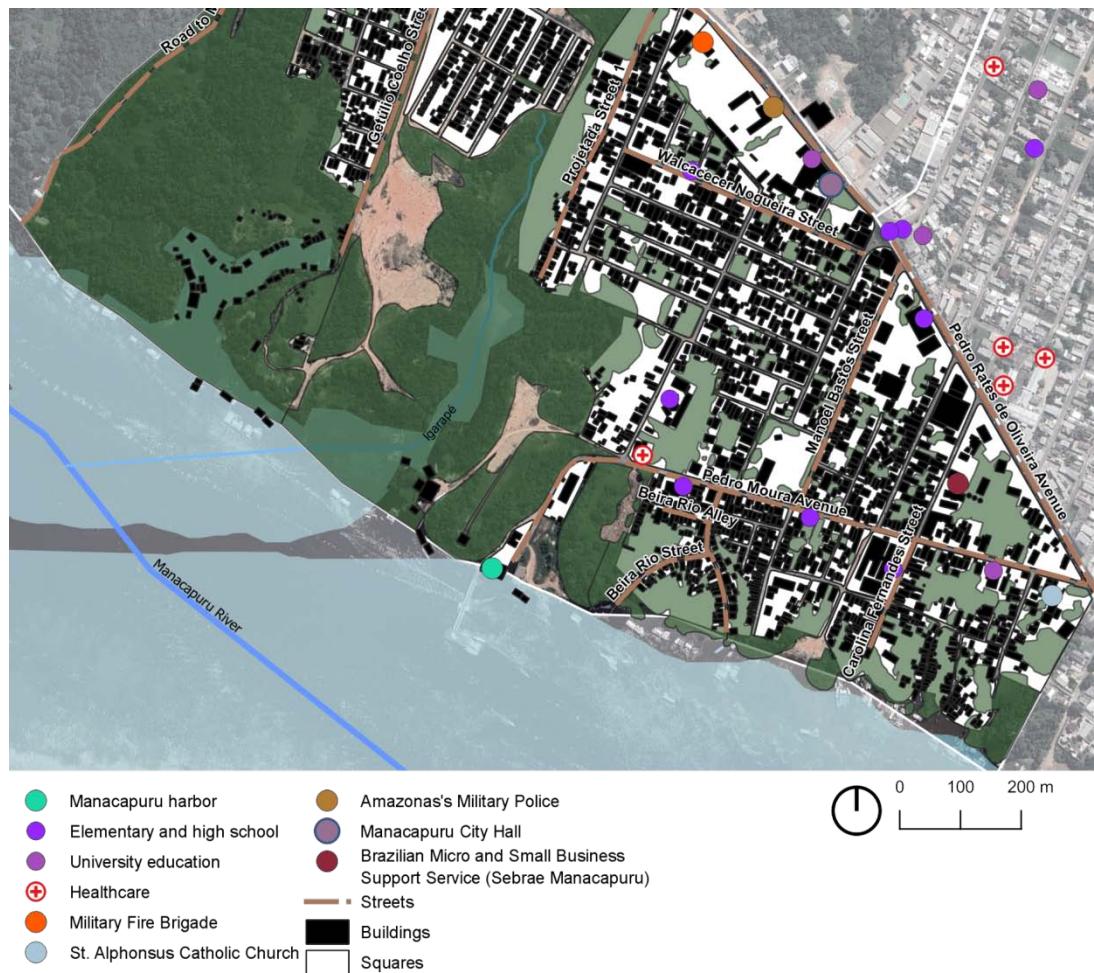
Figure 4: Map of urban elements and environmental composition in the Terra Preta neighborhood.

In terms of territory, the Terra Preta neighborhood occupies a large block with higher elevations than Correnteza. On the map above, the highest points in the area appear on Manoel Urbano Road, which is an extension of the Pedro Rates de Oliveira Avenue Boulevard. It can be seen that a long stream begins a little above the Manoel Urbano road and continues parallel to Projetada Street, the upper part of Figure 4. The lowest quotas are next to the Solimões River, like Beira-rio street, the shape of which represents the outline of a creek next to the Port of Manacapuru. The two red spots represent the risk of landslides, as shown in Figure 5.

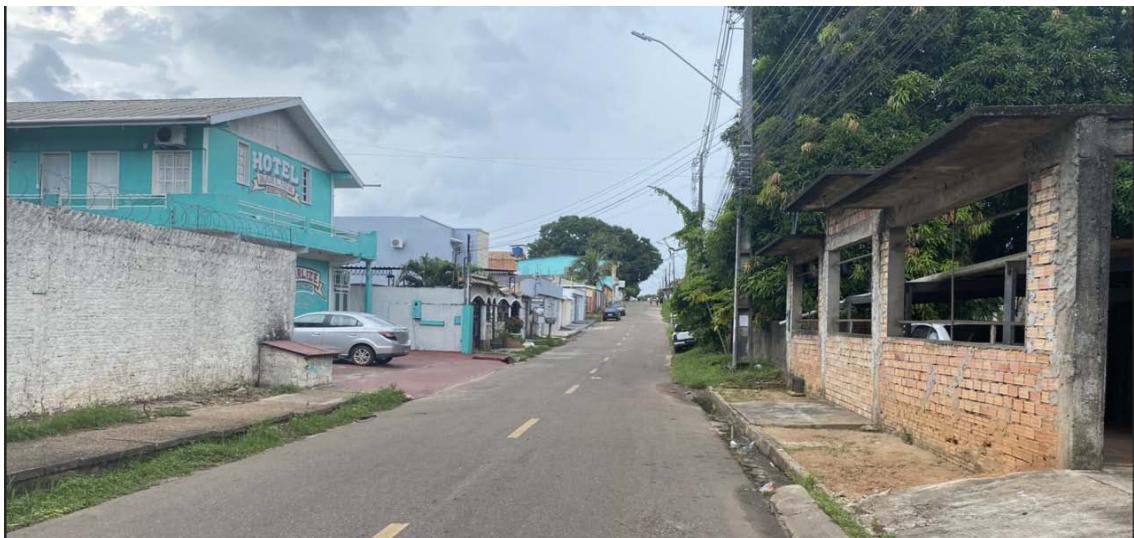
Figure 6: Walcace Nogueira houses

Regarding the materiality of the buildings, it was observed that most buildings in the Terra Preta neighborhood are made of masonry with one floor or two. The areas close to Solimões are more vulnerable to flooding, the villas are made of wooden stilts. Figure 06 shows Walcace Nogueira Street, and in this area it observed the predominance of buildings built in

masonry. Figure 07 shows houses on Beira-Rio Street with colors typical of riverside communities. On the left side, we can see houses made of wooden stilt and on the right side, masonry houses. Image 08 shows a house next to Solimões that is in a significantly deteriorated stage.

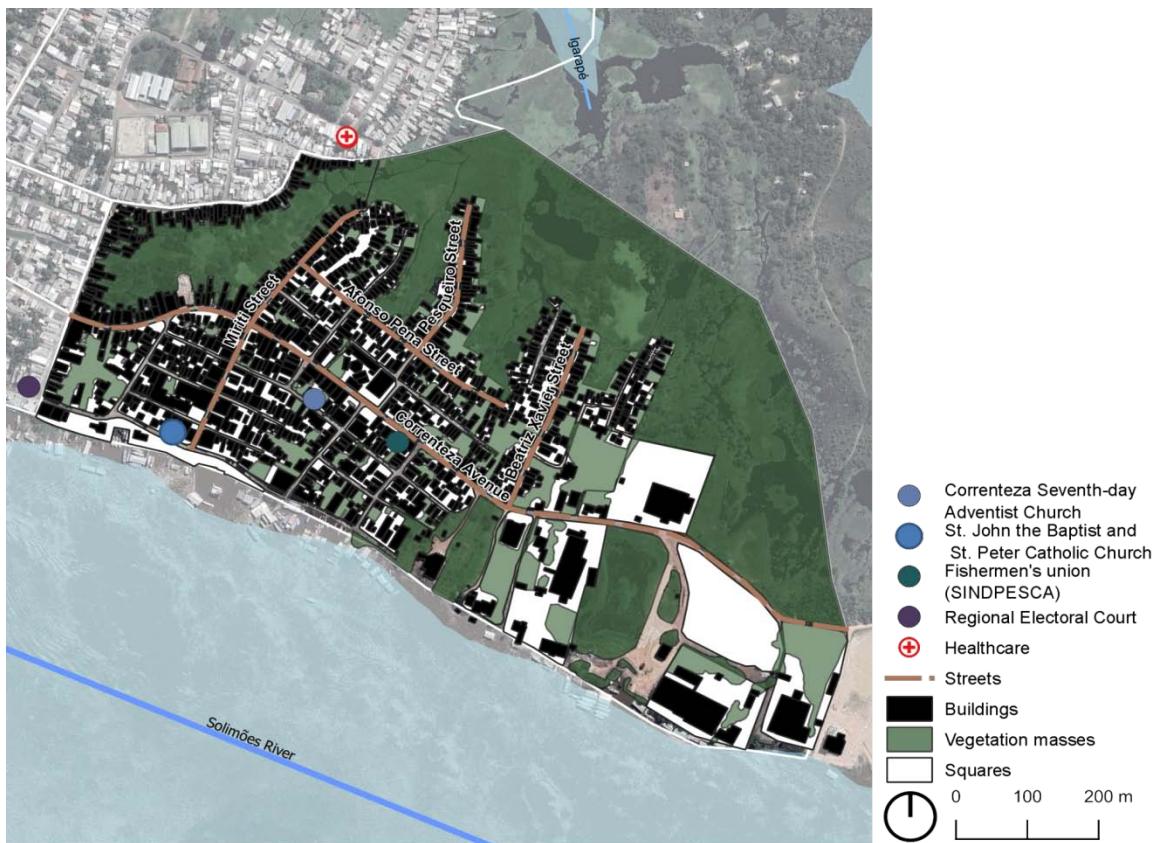
Figure 9: Map of urban elements and environmental composition in the Correnteza neighborhood

Correnteza neighborhoods (Lima, 2012). The illustration 09 depicts the urban setting of the Correnteza neighborhood, including residential structures, commercial activities, educational institutions, a church,

and the fishing sector. According to IBGE (2010), 4702 people lived in the Correnteza.

The Solimões River can be seen in front of the cities, and the green masses represent springs due to the shallowness of the soil and the ease with which

water emerges. The main avenue of the neighborhood is the Avenue of the Correnteza. From the street Afonso Pena, water springs extend until the back of the city, at the time of the flood, forms a lake where residents park boats, as a fishermen's street.

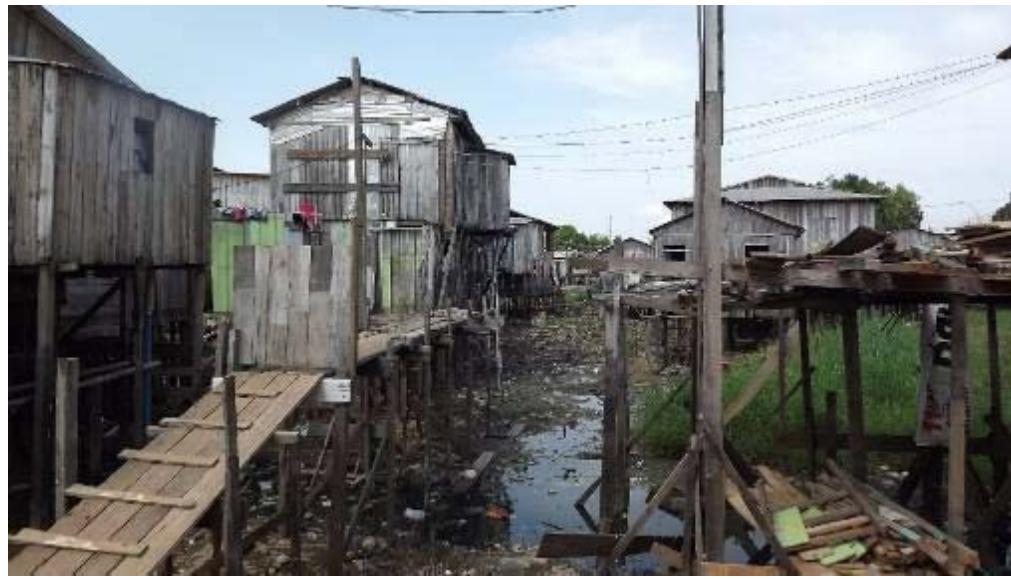
Figure 10: Houses made of stilts in Correnteza neighborhood

The construction of stilts was applied by several peoples, with traditional technique passed down from father to son. Its application in general is in the regions of beach, mountains, and floodplain. Zhang Xu & Wang (2022, p.1), study the village of Tujia in China, which uses the construction system on wooden stilt, and the importance of "conservation and regeneration can keep traditional building systems alive and sustainable", with the first floor is raised from the ground to adapt to the "different terrains". In his sketches, it is noted that the main pillars support the elements of the roof, "wooden stakes in the under the building". The buildings in Manacapuru lost relevant elements to maintain the comfort of the buildings and extend their life cycle. The construction uses metal tiles, small eaves, no balconies around the house, etc. The majority of housing buildings in the Correnteza neighborhood are made of wooden stilts, on average 60% of them are wooden, and 40% are masonry. As shown in Figures 10 and 11:

The wooden structures and walls of the houses as shown in figures 10 and 11 present conservation and maintenance issues. According to the civil defense of

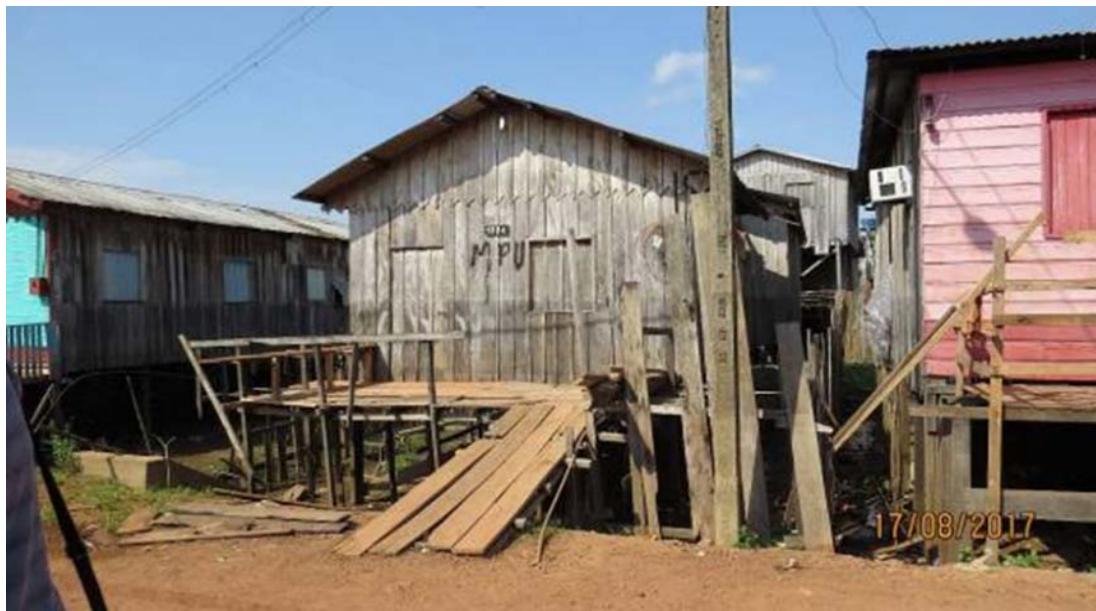
Figure 11: Houses in the Afonso Pena Street—Correnteza neighborhood at risk

The loss of equilibrium in riverside houses in the Manacapuru region is attributed to various factors, mainly to the weight of wooden posts on fragile soil. The second factor, "seasonal fluctuations between floods and dry" causes the wood to rot in the ground. The third characteristic that leads to the loss of overall stability of homes is "the lack of structural bracing elements in the buildings; these were applied during construction, but removed by builders at the end of the work." (Meirelles et al., 2019, p.96).

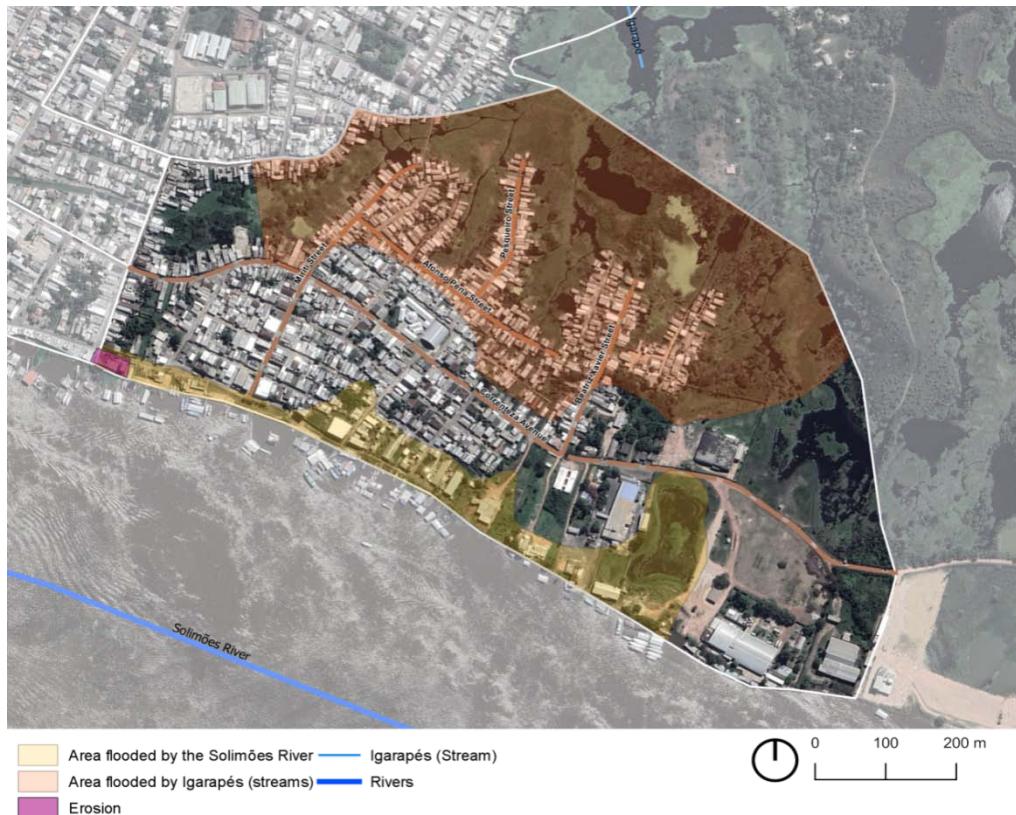
Figure 12: depicts the areas that are most susceptible to flooding in the Correnteza neighborhood and the associated geological hazards.

susceptible to flooding. The influence of internal streams was shaded in light pink, and the flood-prone area next to Solimões was shaded in light yellow. One point of risk to erosion stands out next to the Solimões River, but it can be seen that this is isolated. As shown in the image below, during floods, houses in low-lying areas, close to springs and stream networks, become isolated. This often happens on the streets of Afonso Pena, Miriti, Pesqueiro and Beatriz Xavier.
